Silver Creek: A Study of Stream Velocities and Erosion along the Ohio River near Clarksville, Indiana

McAlpine Lock and Dam Numerical Model

Final report

Prepared for U.S. Army Corps of Engineers, Louisville District

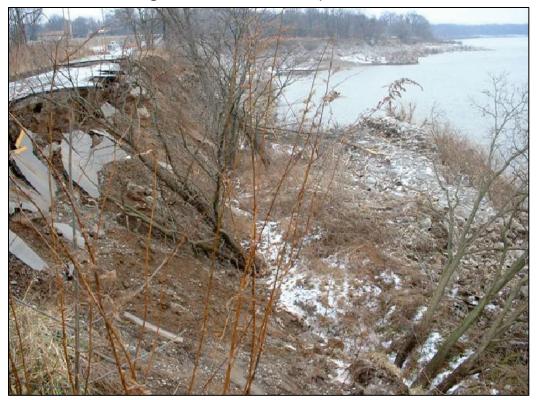
This study resulted from the 2015 report *Ohio River Shoreline, McAlpine Locks and Dam Caving Bank Condition, Clarksville, Indiana Followup Assessment Report*, by the USACE Louisville District (USACE 2015). The report includes findings from an investigation of bank failure and erosion issues on the north shore of the Ohio River between RM 605.5 and 606.5. The report presents a summary of prior studies, reports, and projects dating back to 1973 that address the erosion. Figure 2 is an image from a 2004 bank erosion event that was included in the report. The previous report concludes that the shoreline failure is likely a combination of geotechnical and hydraulic issues and that potential measures to address the problem include construction of bank revetment, shoreline walls, or dike jetties.

Figure 2. 2004 Bank erosion in problem area.
